TITLE: DAMAGE RESISTANCE OF AR-COATED GERMANIUM SURFACES
FOR NANOSECOND CO₂ LASER PULSES

AUTHOR(S): Brian E. Newnam, AP-2
Dennis H. Gill, AP-2

SUBMITTED TO: Proceedings of:
1977 Symposium on Optical Materials
for High Power Lasers (Damage
Symposium).

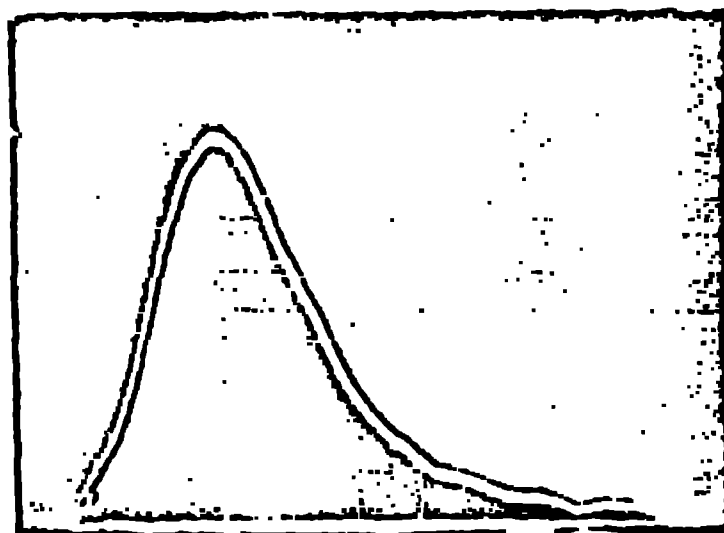
Figure 2.

0.5 nsec per
division

20 nsec per
division

Laser damage tests were conducted with $1.15 \pm 0.05 \text{ ns}$ pulses (FWHM) at the P(20) 10.6 μm wavelength. These short pulses were reliably carved out of a smoothed gain-switched pulse by use of a Pockel cell arrangement. The schematic of the laser diagnostics is shown in figure 1. Pulswidth measurements were made with a Molectron pyroelectric detector coupled to a 5 GHz bandwidth oscilloscope of LASL design [3]. For supplementary tests with a 70-ns pulswidth, a photon-drag detector was used. Oscillograms of the temporal pulses are shown in figure 2.
